**Re: Metal Bank Cottman Avenue NPL Site
Monthly Report due June 10, 2013
Reporting Period: May 1 through May 31, 2013**

Project Name: Metal Bank NPL Site	For the Month: May 2013	
Project Location: Philadelphia, PA	Report Number: 86	Dated: June 10, 2013

Re: Report
Sheet Pile Wall Inspection
Metal Bank NPL Site
7301 Milnor Street
Philadelphia, PA 19136

This report is submitted in accordance with our agreement dated November 12, 2012. It covers our general understanding of the construction and purpose of the sheet pile wall at the referenced site. It also covers a visual structural evaluation of the sheet pile wall, identification of maintenance repairs and development of a monitoring plan.

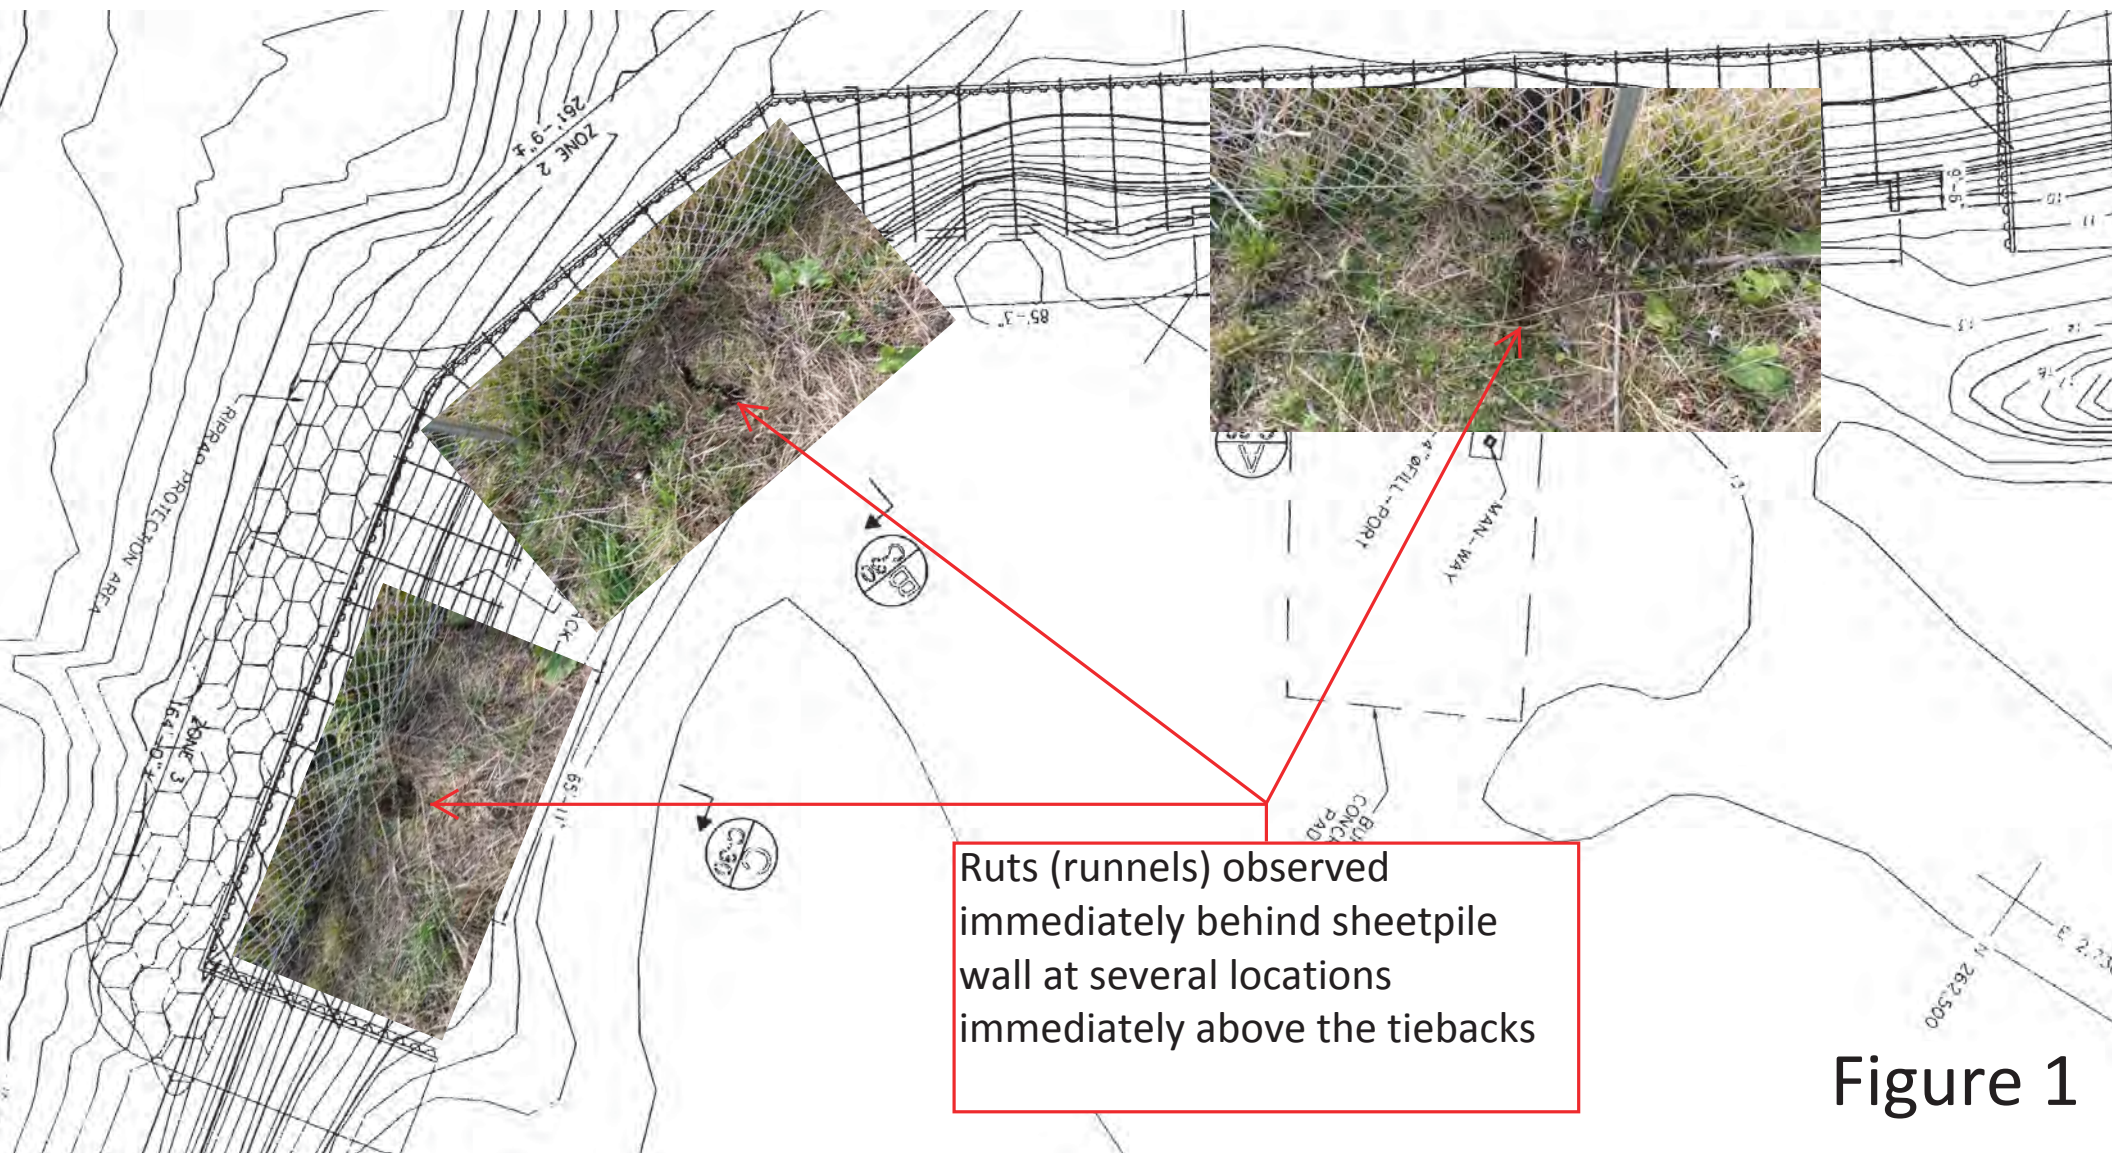
Figure 1

1. Small ruts (runnels) were observed in a few locations immediately behind the sheetpile wall on the landside above the tieback locations as shown on Figure 1. There is no evidence of soil migrating through the sheets at these locations.

1. The sheetpile wall sections show the tiebacks were installed through a 10-in diameter PVC sleeve pipe. The ruts may be attributed to:
 - a. Migration of soil into the PVC sleeve.
 - b. Difficulties compacting around the pile during placement of the fill.
 - c. Lateral movement of the sheet (waterside) creating voids or loosening of the soil around the PVC pipe.
 - d. Water flow in and around the PVC pipe.

In our opinion the few small ruts are inconsequential, nevertheless, we recommend filling the ruts to minimize migration of storm water runoff channeling below grade. Local excavations should be made immediately adjacent to the ruts about 1-ft depth below existing site grade. The ruts and local excavation should be filled and compacted in 6-in lifts with “jumping jack” or walk behind vibratory plate compactor until grade is level. The fill soil should comply with the original project specifications. Replace vegetation in kind.

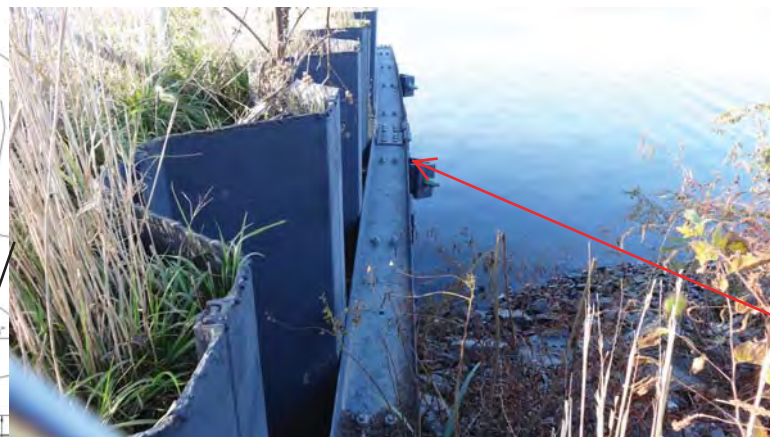
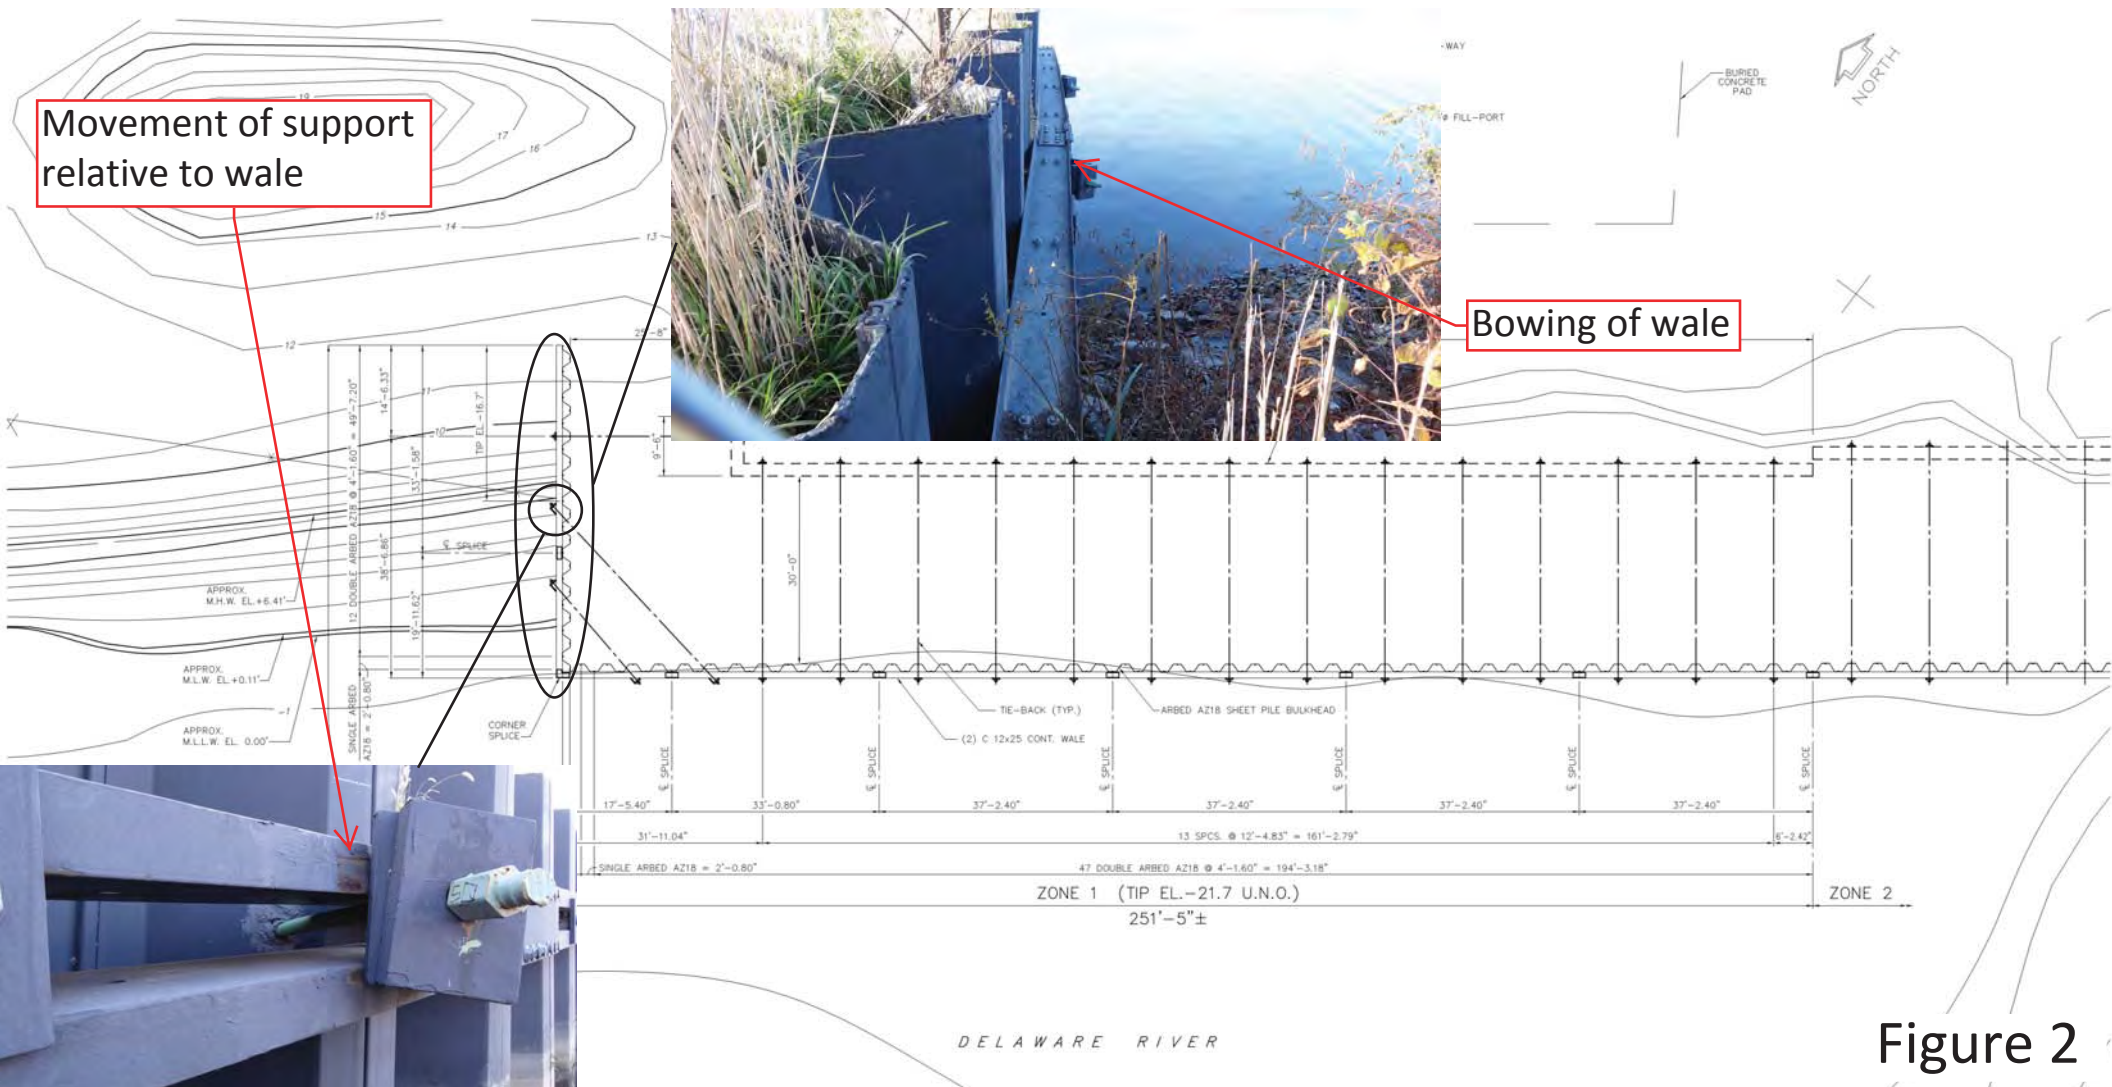
3. The north side of Zone 1 shows movement of the sheetpile wall system. Evidence of movement of the tieback plates relative to the wale was observed by scraping and removal of the epoxy coating on the face of the wale. In addition, the wale and sheetpile wall appear to be bowing with the apex of the bow at the bolted connection. Refer to Figure 2 for location and photographs.

Movement of support
relative to wale

Bowing of wale

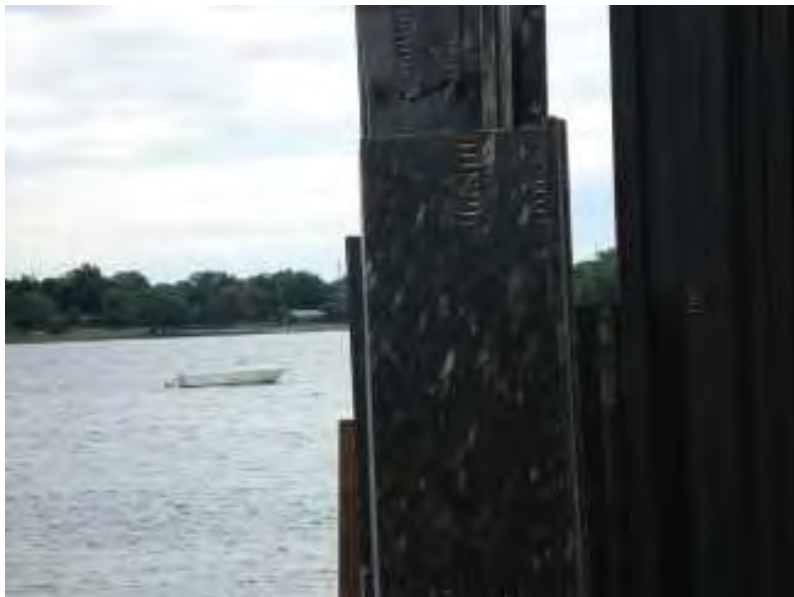
Photo 1

I visited the site on August 28, 2008 to observe the condition of the sheet piles driven to-date at Zone 3. As indicated by the photos below, some of the piles were visibly out-of-plumb both to the east (Photo 1) and north (Photo 2).

It appears that the piles were refusing on the underlying weathered schist above the design tip elevation of -40.0 feet and additional energy was applied in an attempt to reach -40.0 feet. This is a likely cause of the out-of-plumbness.

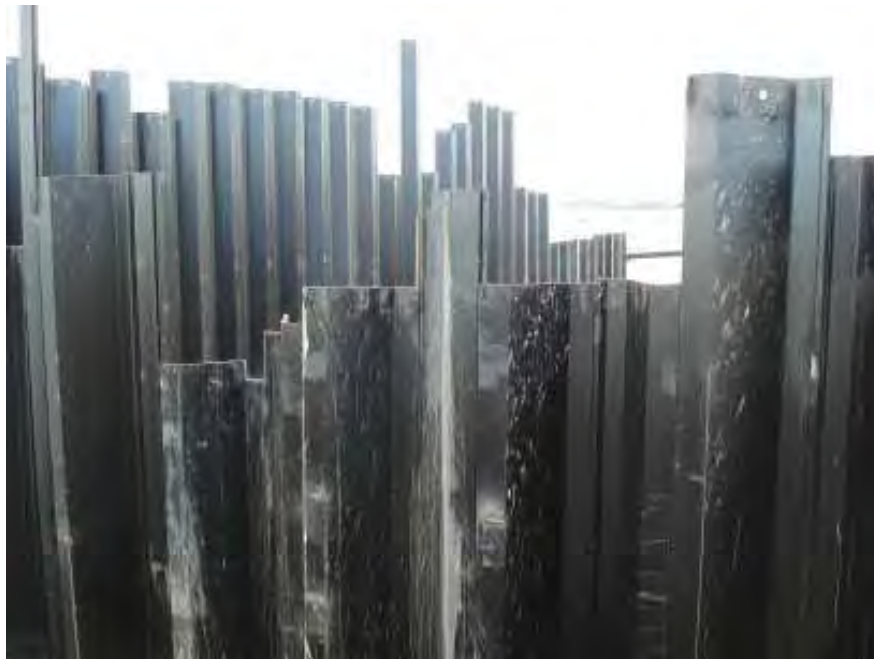
Photo 3

In addition, some of the pile tops were visibly damaged (Photo 3).
